SERVICE BULLETIN

Bulletin No. 001

Product: Model J Booster Heaters

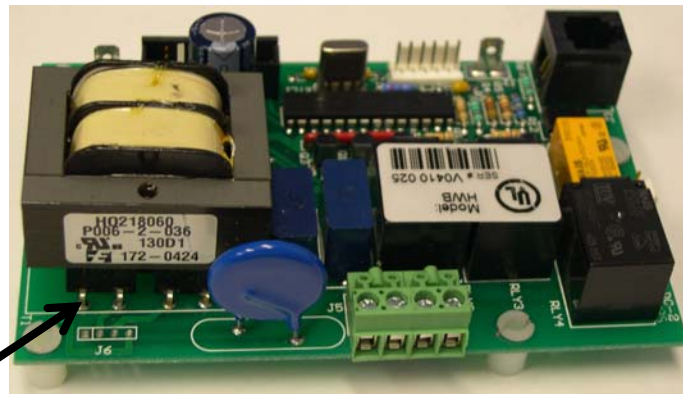
Background: The transformer located on the T1000 control board can develop a hairline crack in the left hand corner solder joint (see photo). This prevents power from being supplied to the display module, resulting in the booster heater becoming inoperable.

Hairline Crack

Current Status: All new T1000 control boards have an improved transformer mounting. Additionally, all circuit boards now utilize a rubber grommet and stand-off.

Remarks/Action: The transformer solder joint can be repaired in the field by re-soldering the cracked joint. If repair can not be easily performed, then replace the T1000 and return the component to Hubbell.
